EXHIBIT I1

APPRAISAL REPORT & RMS 11

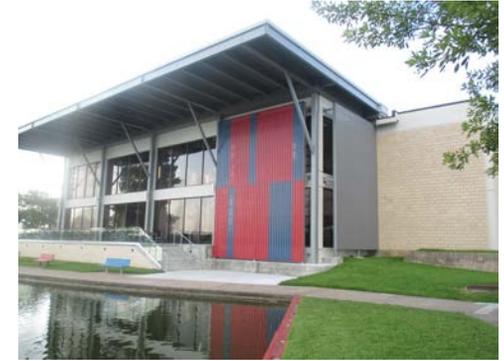
Exterior Walls: BRICK ON MASONRY.
 Exterior Walls: PRECAST CONCRETE PANEL.
 Exterior Walls: METAL SIDING ON MASONRY
 Fire Sprinkler System: NO
 Fire Alarms - Manual: YES
 Fire Alarms - Automatic: YES
 Smoke / Heat Detectors: YES
 Fire Extinguishers: YES
 Emergency Exit Signs / Lighting: YES

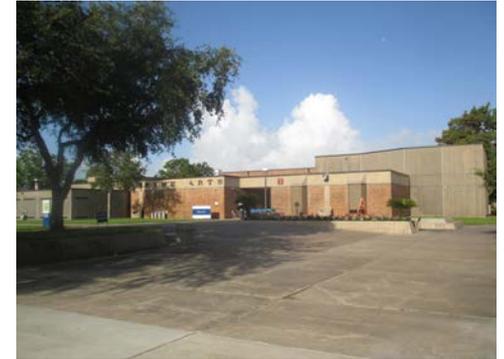
Exterior Walls: BRICK ON MASONRY.
 Exterior Walls: PRECAST CONCRETE PANEL.
 Exterior Walls:
 Fire Sprinkler System: NO
 Fire Alarms - Manual: YES
 Fire Alarms - Automatic: YES
 Smoke / Heat Detectors: YES
 Fire Extinguishers: YES
 Emergency Exit Signs / Lighting: YES

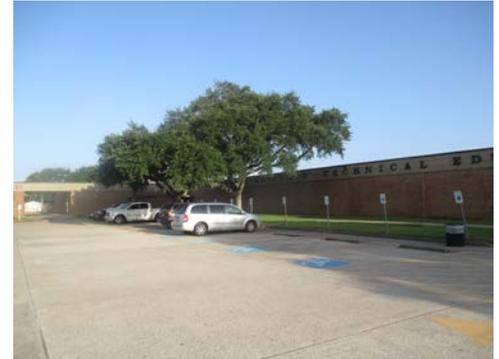
Exterior Walls: BRICK ON MASONRY.
 Exterior Walls: PRECAST CONCRETE PANEL.
 Exterior Walls: STUCCO ON MASONRY.
 Fire Sprinkler System: NO
 Fire Alarms - Manual: YES
 Fire Alarms - Automatic: YES
 Smoke / Heat Detectors: YES
 Fire Extinguishers: YES
 Emergency Exit Signs / Lighting: YES
 Additional Features: COVERED ENTRANCES, AUDITORIUM SEATING
 Contents: FURNITURE,COMPUTERS,SCIENCE EQUIPMENT

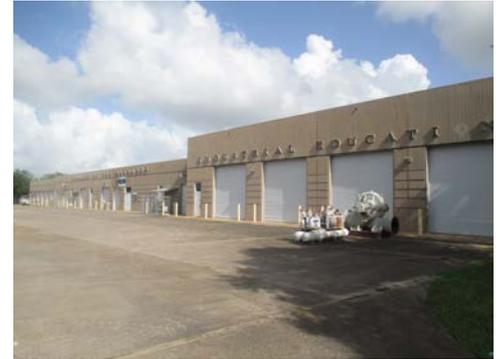
Exterior Walls: PRECAST CONCRETE PANEL.
 Exterior Walls:
 Exterior Walls:
 Fire Sprinkler System: NO
 Fire Alarms - Manual: YES
 Fire Alarms - Automatic: YES
 Smoke / Heat Detectors: YES
 Fire Extinguishers: YES
 Emergency Exit Signs / Lighting: YES

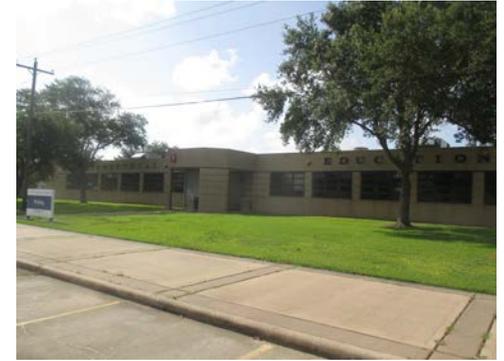
Exterior Walls: PRECAST CONCRETE PANEL.

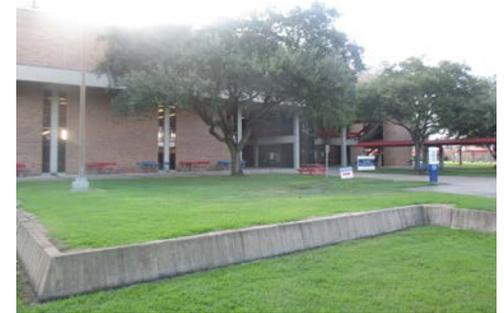
Exterior Walls: BRICK ON MASONRY.
 Exterior Walls: PRECAST CONCRETE PANEL.
 Exterior Walls:
 Fire Sprinkler System: NO
 Fire Alarms - Manual: YES
 Fire Alarms - Automatic: YES
 Smoke / Heat Detectors: YES
 Fire Extinguishers: YES
 Emergency Exit Signs / Lighting: YES

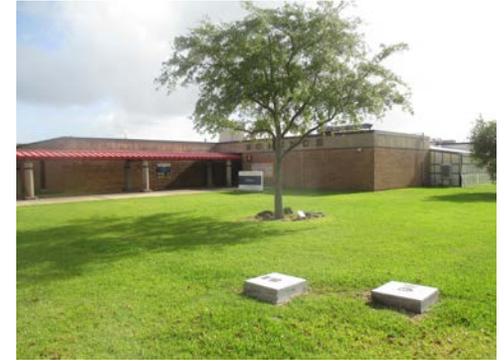
Exterior Walls: BRICK ON MASONRY.
 Exterior Walls: PRECAST CONCRETE PANEL.
 Exterior Walls:

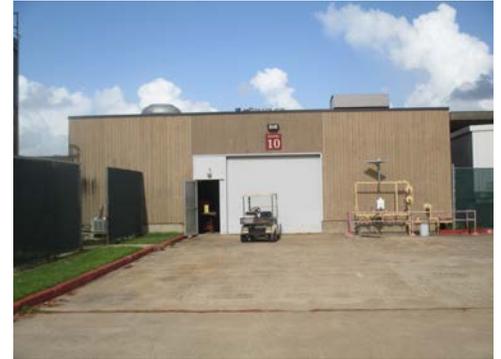
Exterior Walls: CONCRETE TILT UP PANELS

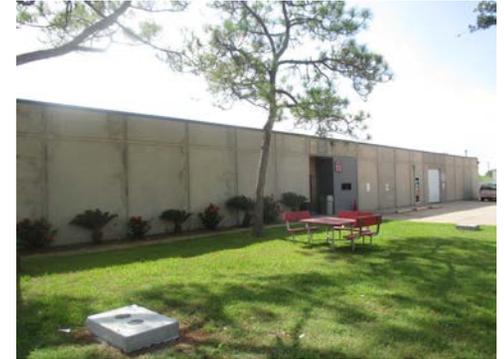
Exterior Walls: STUCCO ON MASONRY.
 Exterior Walls: PRECAST CONCRETE PANEL.
 Exterior Walls:
 Fire Sprinkler System: NO
 Fire Alarms - Manual: YES
 Fire Alarms - Automatic: YES
 Smoke / Heat Detectors: YES
 Fire Extinguishers: YES
 Emergency Exit Signs / Lighting: YES

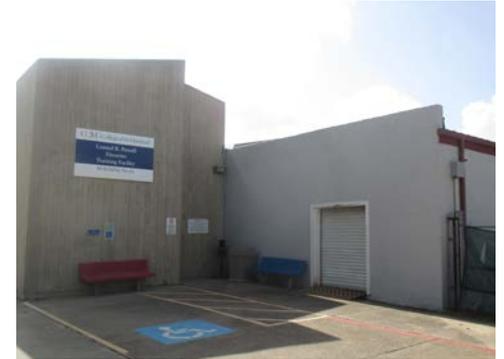
Exterior Walls: STUCCO ON MASONRY.
 Exterior Walls: CONCRETE TILT UP PANELS
 Exterior Walls:
 Fire Sprinkler System: NO
 Fire Alarms - Manual: YES
 Fire Alarms - Automatic: YES
 Smoke / Heat Detectors: YES
 Fire Extinguishers: YES
 Emergency Exit Signs / Lighting: YES
 Additional Features: COVERED ENTRANCE
 Contents: FURNITURE, COMPUTERS, FIREARM TRAINING EQUIPMENT

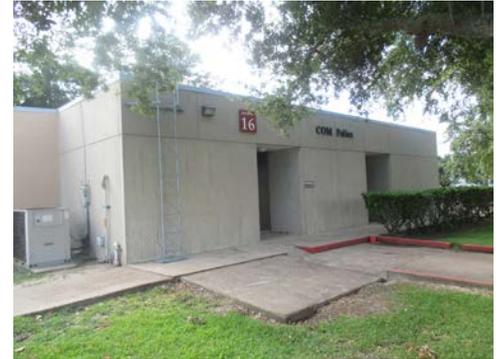
Exterior Walls: PRECAST CONCRETE PANEL.
 Exterior Walls: STUCCO ON MASONRY.
 Exterior Walls:
 Fire Sprinkler System: NO
 Fire Alarms - Manual: YES
 Fire Alarms - Automatic: YES
 Smoke / Heat Detectors: YES
 Fire Extinguishers: YES
 Emergency Exit Signs / Lighting: YES

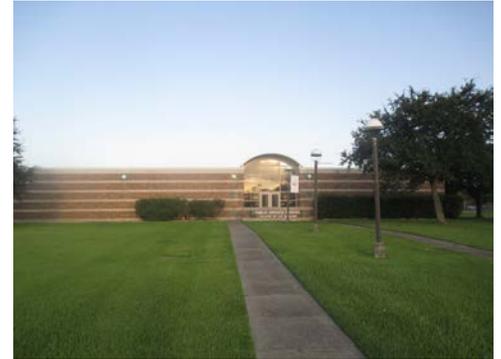
Exterior Walls: BRICK ON MASONRY.
 Exterior Walls:
 Exterior Walls:
 Fire Sprinkler System: NO
 Fire Alarms - Manual: YES
 Fire Alarms - Automatic: YES
 Smoke / Heat Detectors: YES
 Fire Extinguishers: YES
 Emergency Exit Signs / Lighting: YES

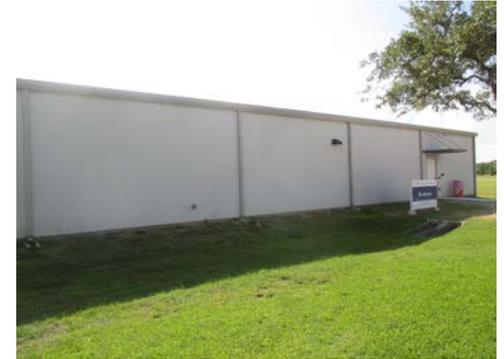
Exterior Walls: METAL SIDING ON GIRTS.
 Exterior Walls:
 Exterior Walls:
 Fire Sprinkler System: NO
 Fire Alarms - Manual: NO
 Fire Alarms - Automatic: NO
 Smoke / Heat Detectors: YES
 Fire Extinguishers: YES
 Emergency Exit Signs / Lighting: YES

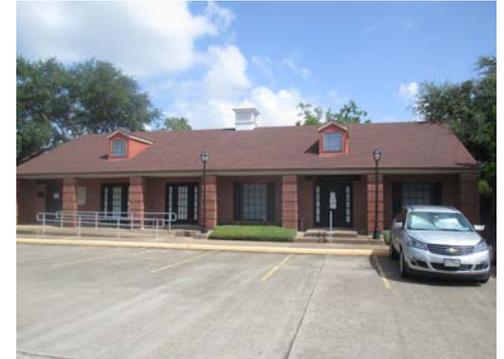
Exterior Walls: BRICK ON FRAME.
 Exterior Walls:
 Exterior Walls:
 Fire Sprinkler System: NO
 Fire Alarms - Manual: YES
 Fire Alarms - Automatic: NO
 Smoke / Heat Detectors: YES
 Fire Extinguishers: YES
 Emergency Exit Signs / Lighting: YES
 Additional Features: COVERED ENTRANCES
 Contents: OFFICE EQUIPMENT,FURNITURE,COMPUTERS

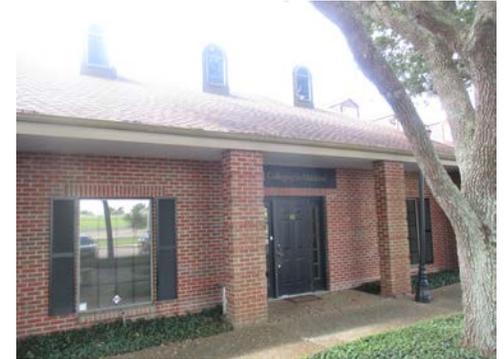
Exterior Walls: BRICK ON FRAME.
 Exterior Walls:
 Exterior Walls:
 Fire Sprinkler System: NO
 Fire Alarms - Manual: YES
 Fire Alarms - Automatic: NO
 Smoke / Heat Detectors: YES
 Fire Extinguishers: YES
 Emergency Exit Signs / Lighting: YES
 Additional Features: COVERED ENTRANCES
 Contents: OFFICE EQUIPMENT,FURNITURE,COMPUTERS

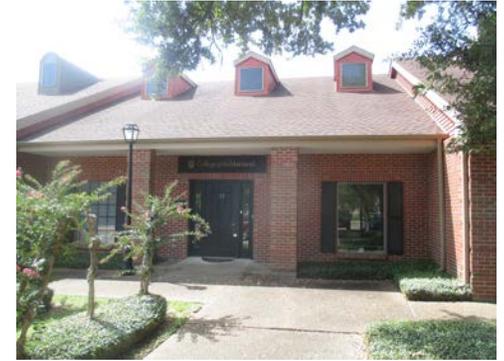
Exterior Walls: BRICK ON FRAME.
 Exterior Walls:
 Exterior Walls:
 Fire Sprinkler System: NO
 Fire Alarms - Manual: YES
 Fire Alarms - Automatic: NO
 Smoke / Heat Detectors: YES
 Fire Extinguishers: YES
 Emergency Exit Signs / Lighting: YES
 Additional Features: COVERED ENTRANCES
 Contents: OFFICE EQUIPMENT,FURNITURE,COMPUTERS

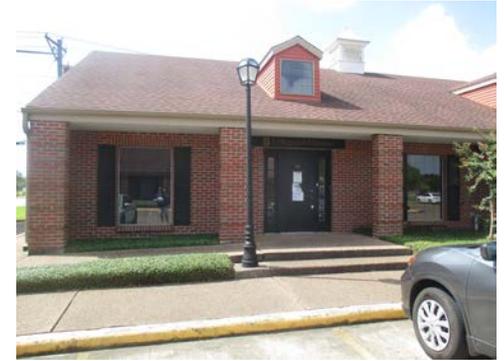
Exterior Walls: BRICK ON FRAME.
 Exterior Walls:
 Exterior Walls:
 Fire Sprinkler System: NO
 Fire Alarms - Manual: YES
 Fire Alarms - Automatic: NO
 Smoke / Heat Detectors: YES
 Fire Extinguishers: YES
 Emergency Exit Signs / Lighting: YES
 Additional Features: COVERED ENTRANCES
 Contents: OFFICE EQUIPMENT,FURNITURE,COMPUTERS

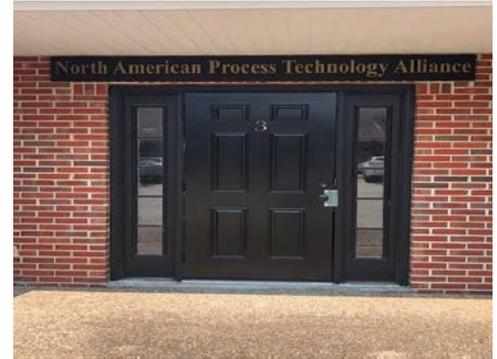
Exterior Walls: BRICK ON FRAME.
 Exterior Walls:
 Exterior Walls:
 Fire Sprinkler System: NO
 Fire Alarms - Manual: YES
 Fire Alarms - Automatic: NO
 Smoke / Heat Detectors: YES
 Fire Extinguishers: YES
 Emergency Exit Signs / Lighting: YES
 Additional Features: COVERED ENTRANCES
 Contents: OFFICE EQUIPMENT,FURNITURE,COMPUTERS
